Rimkus Consulting Group, Inc.
Eight Greenway Plaza, Suite 500
Houston, TX 77046
(800) 580-3228 Telephone
(713) 623-4357 Facsimile

Re: RCG File No: 11009971
LLV Number: 0209452
VMF Location: 1530 Greensmark Drive in Houston, Texas
Subject: Final Report

Rimkus Consulting Group, Inc. was retained to examine LLV 0209452, VIN 1GBCS10E4M2908832. The fire occurred on June 13, 2016 at around 12:30 P.M. the operator of the vehicle at the time of the fire, was unavailable for interview but reportedly stated the vehicle's engine died while delivering mail on his route and backfired during subsequent attempts to restart it. Soon thereafter, smoke was observed from beneath the hood as well as flames.

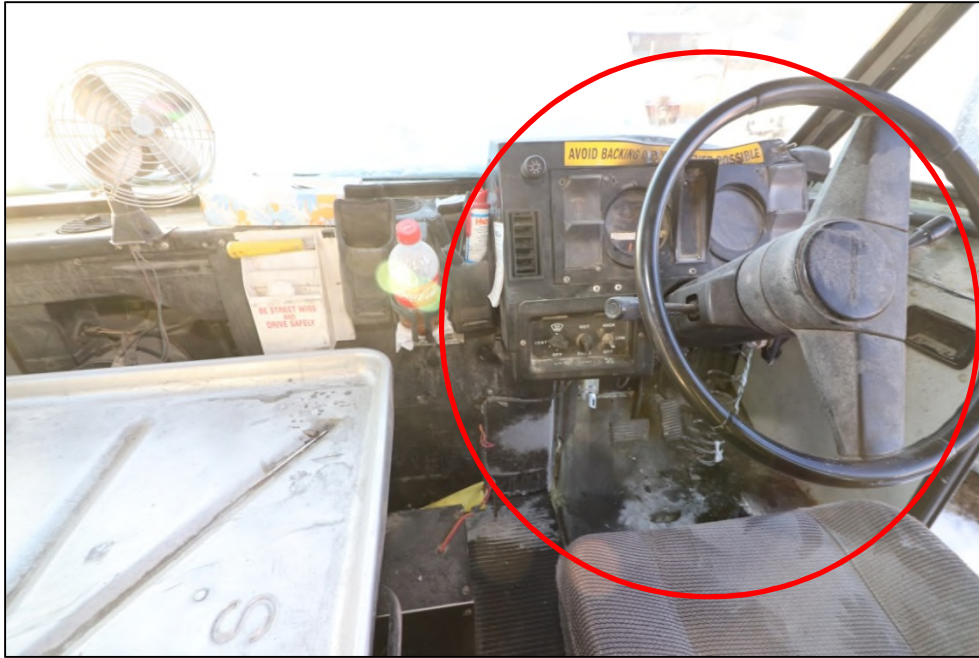
Photograph 3

The interior area, observe the only fire damage to the steering column area.

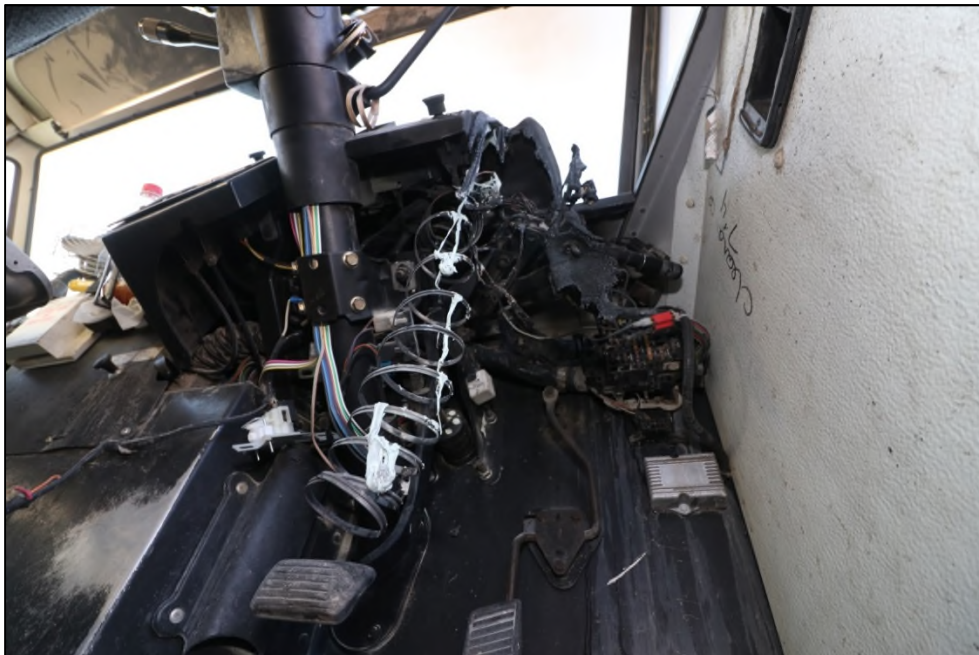
Photograph 4

The interior of the passenger compartment, the fire originated to the right side of the dashboard to the right of the steering column.

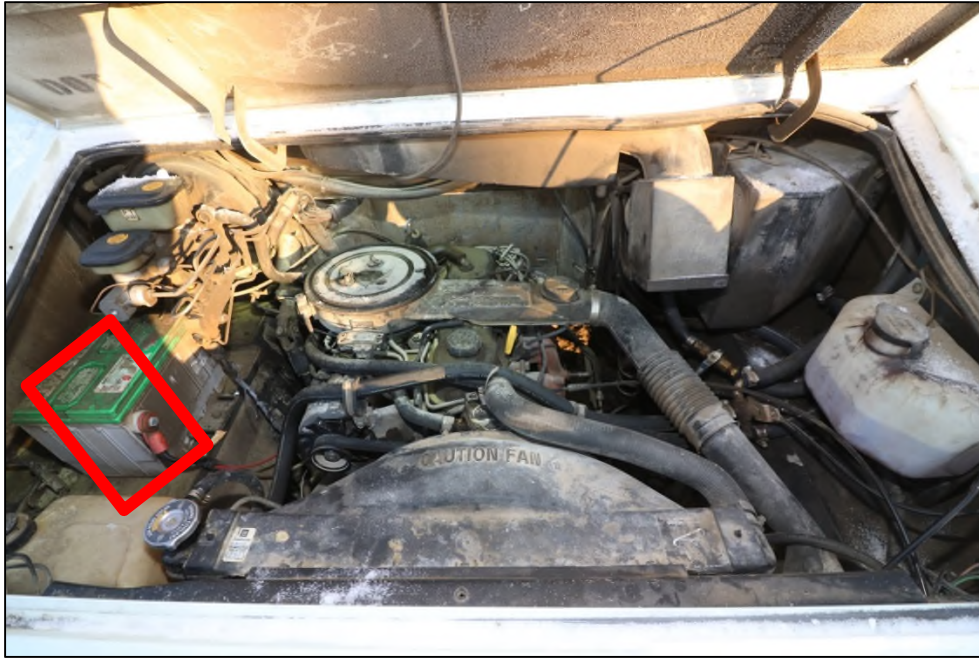
Photograph 5

The engine compartment, fire damage occurred at the right side to a ground conductor.

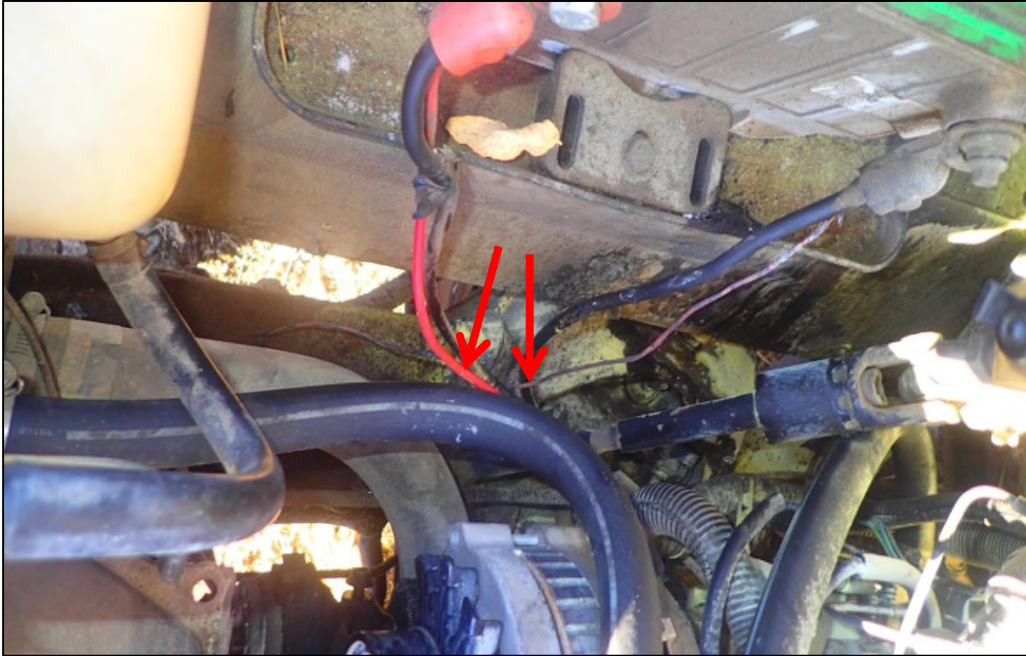
Photograph 7

The ground conductor coming from the battery with evidence of electrical arcing (red arrows).

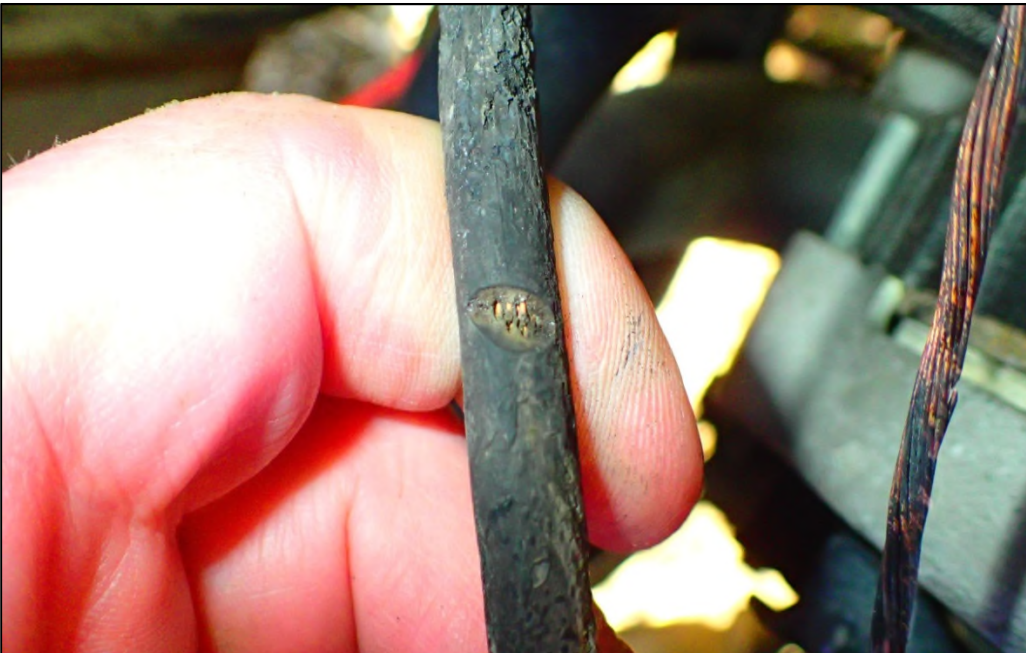
Photograph 8

Pre-fire mechanical damage observed to the wiring showing wear and tear.

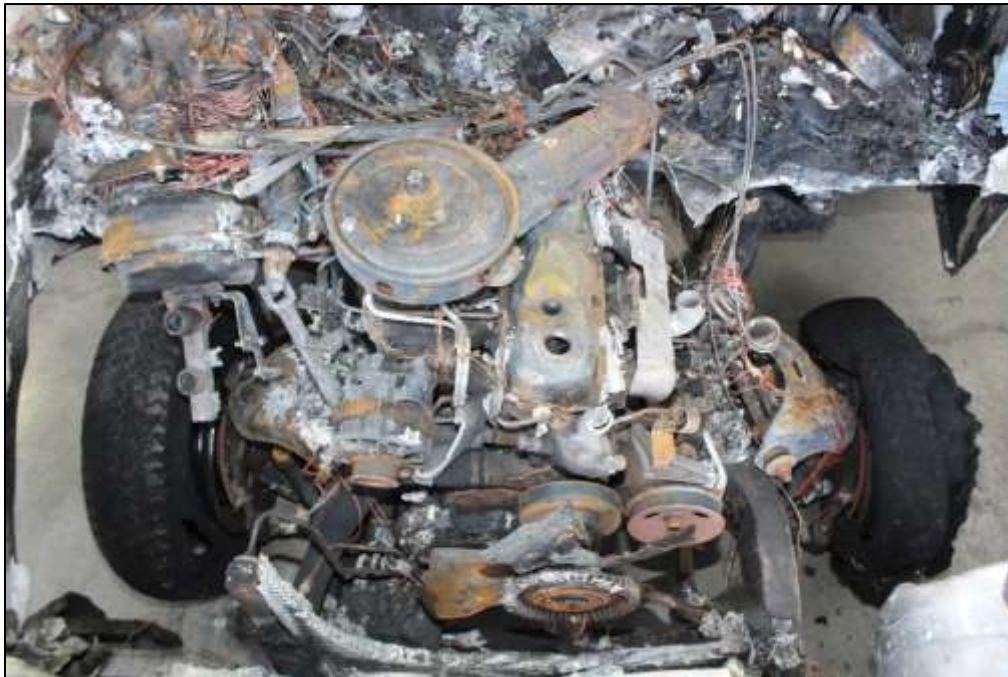
Photograph 7
Engine compartment.

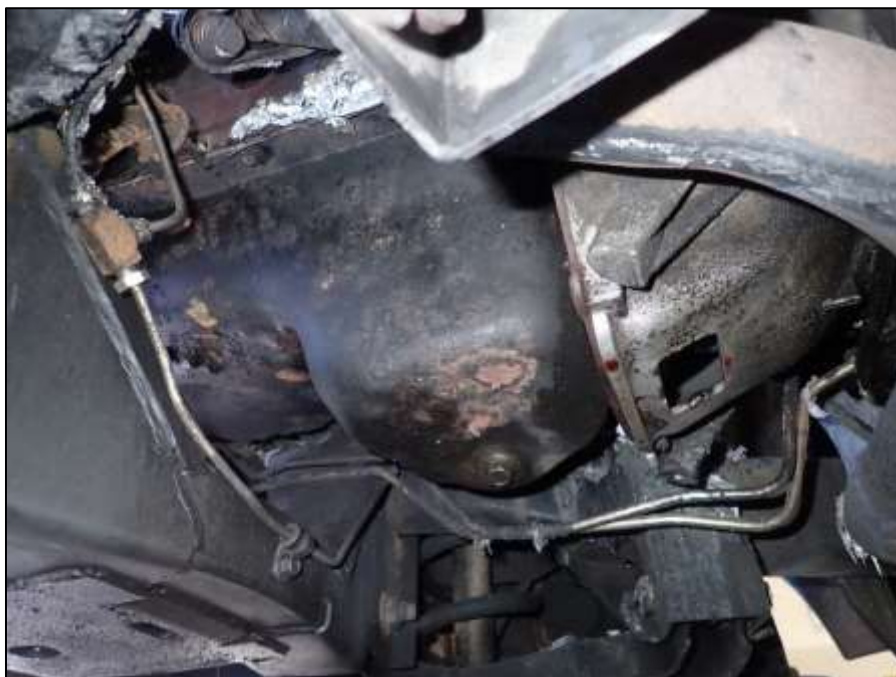
Photograph 8
Undercarriage near the front of the vehicle.

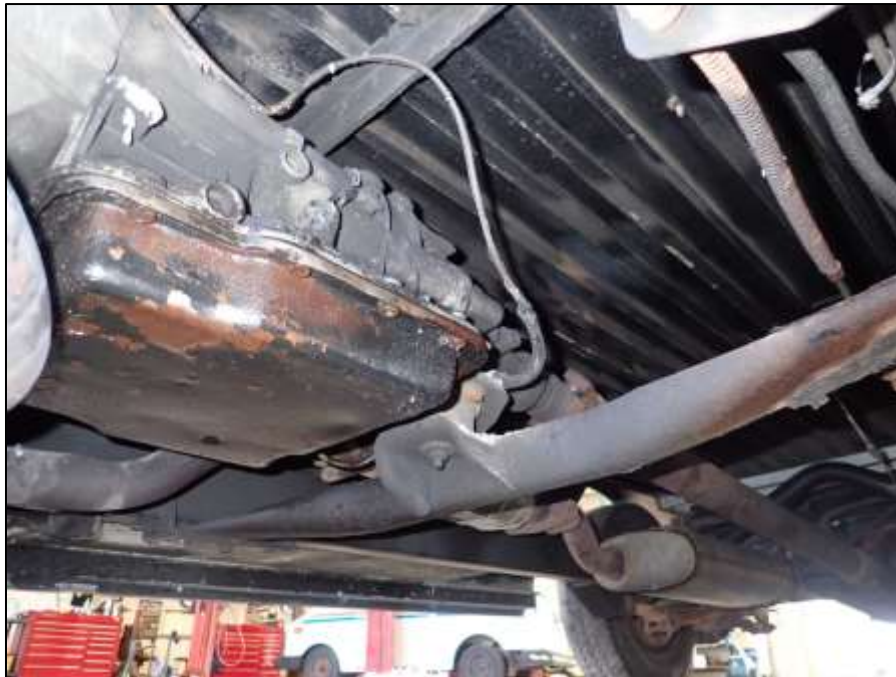
Photograph 9

Undercarriage near the middle of the vehicle.

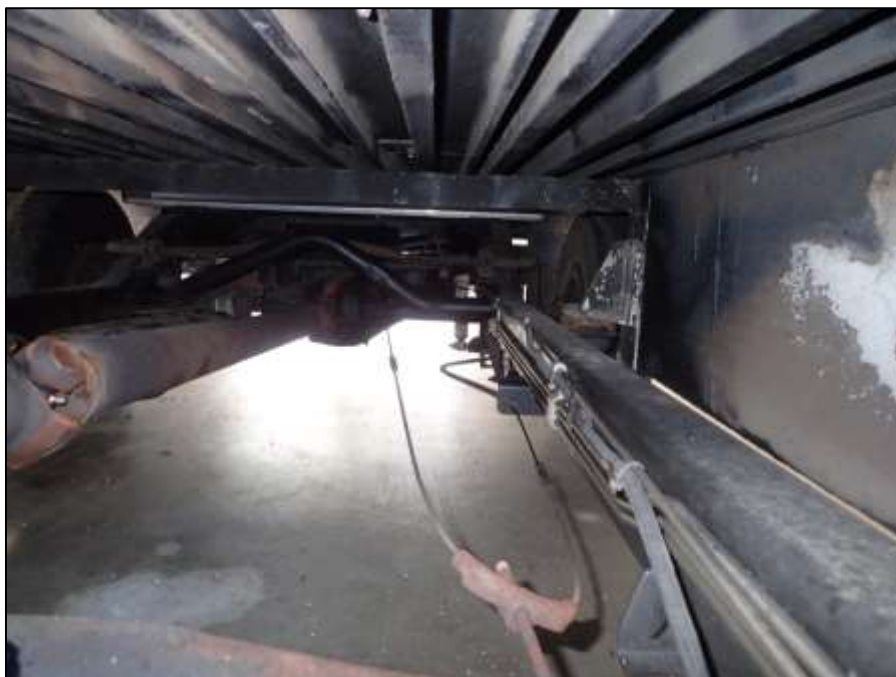
Photograph 10

Undercarriage towards the rear of the vehicle.

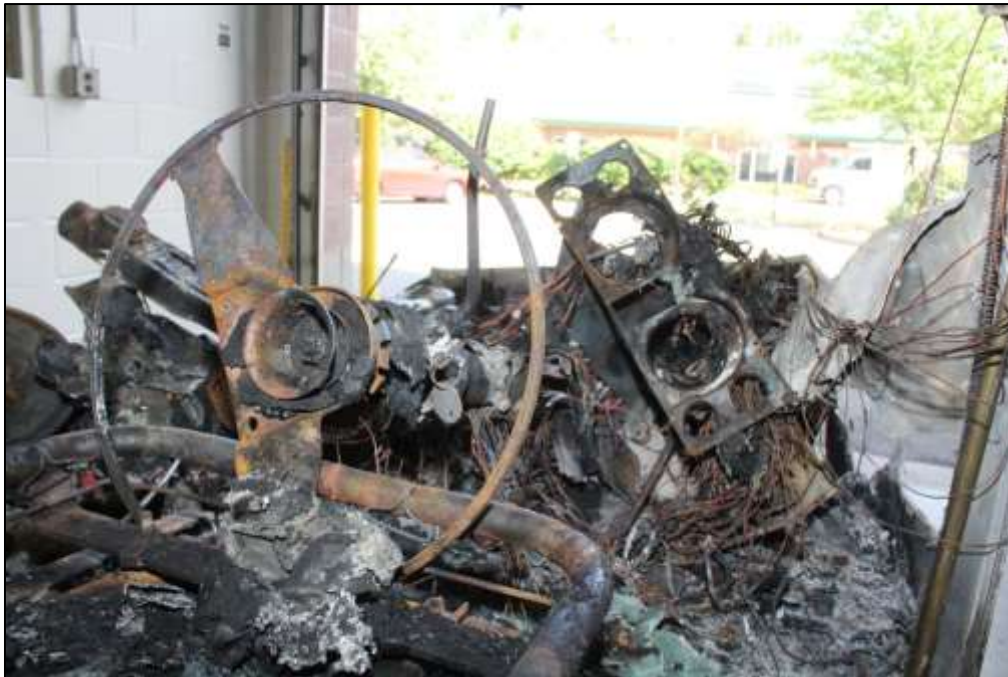
Photograph 11

Dashboard and fuse panel consumption.

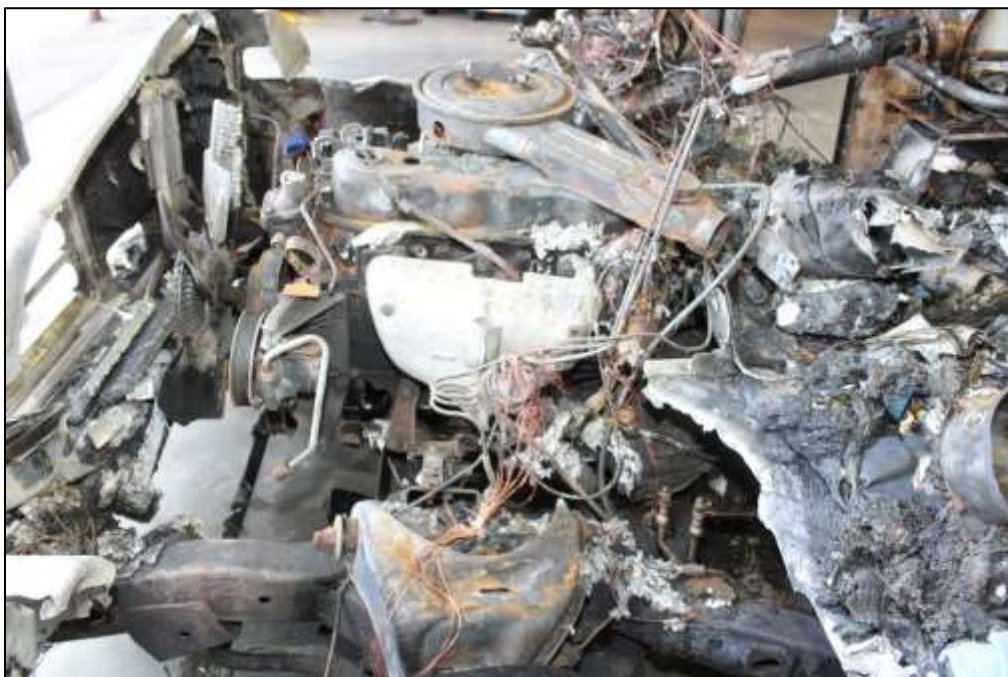
Photograph 12

Area of origin on the mail side of the engine.

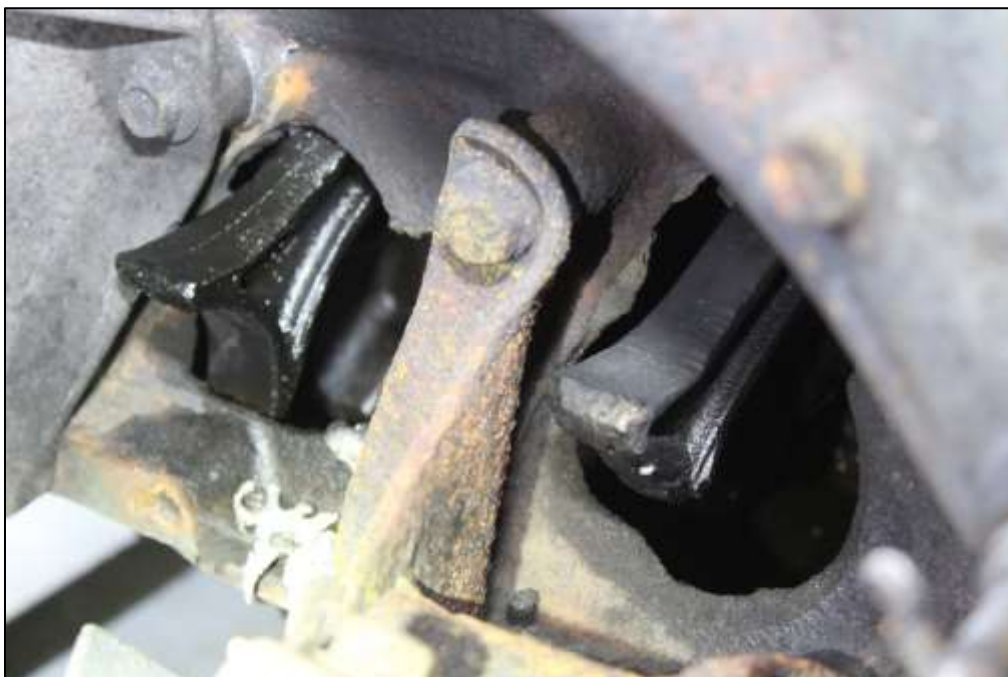
Photograph 14

Two push rods out the side of the engine block.

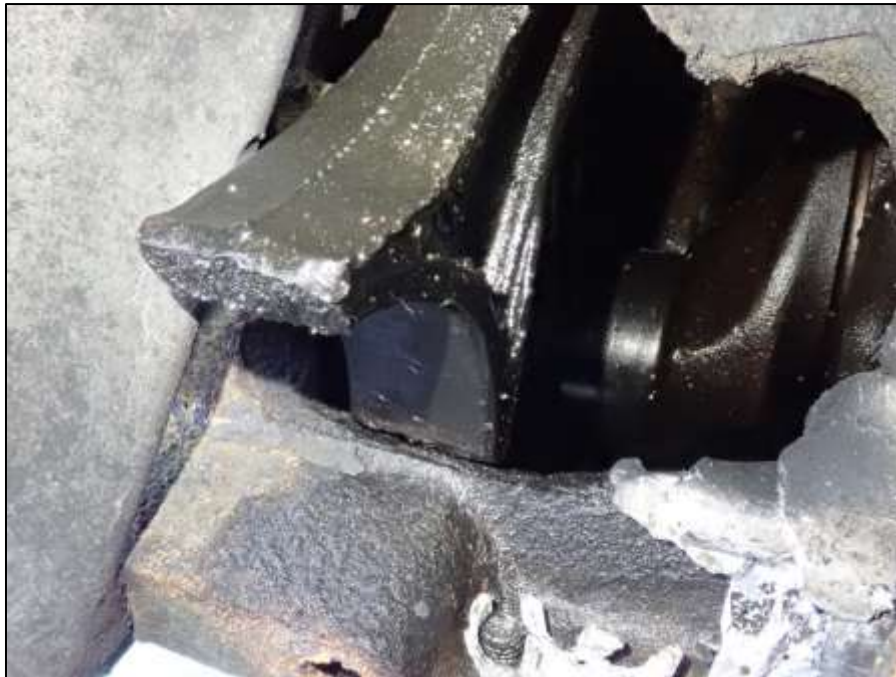
Photograph 15

Cylinder #1 push rod.

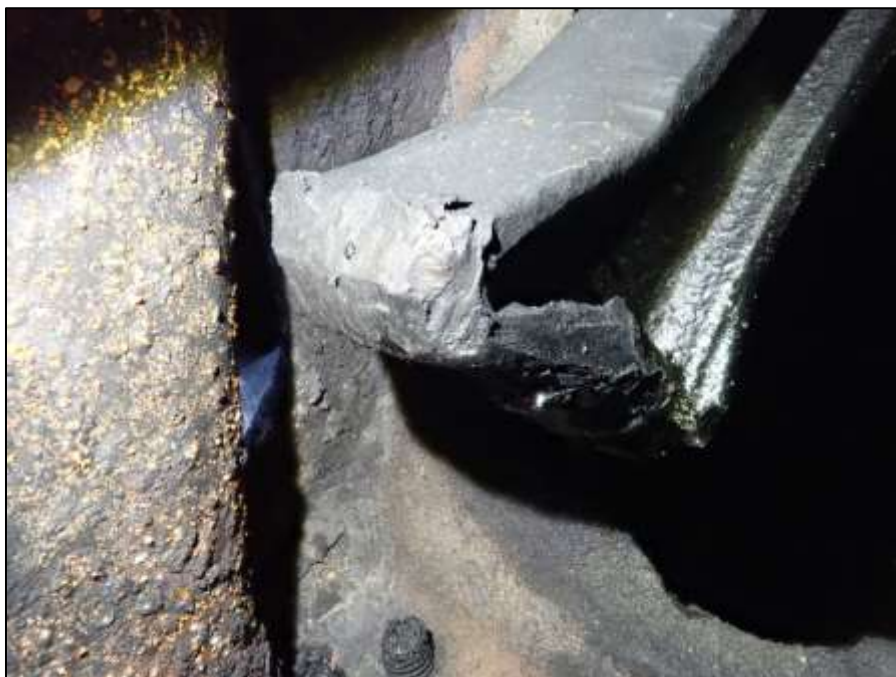
Photograph 16

Cylinder #2 push rod.

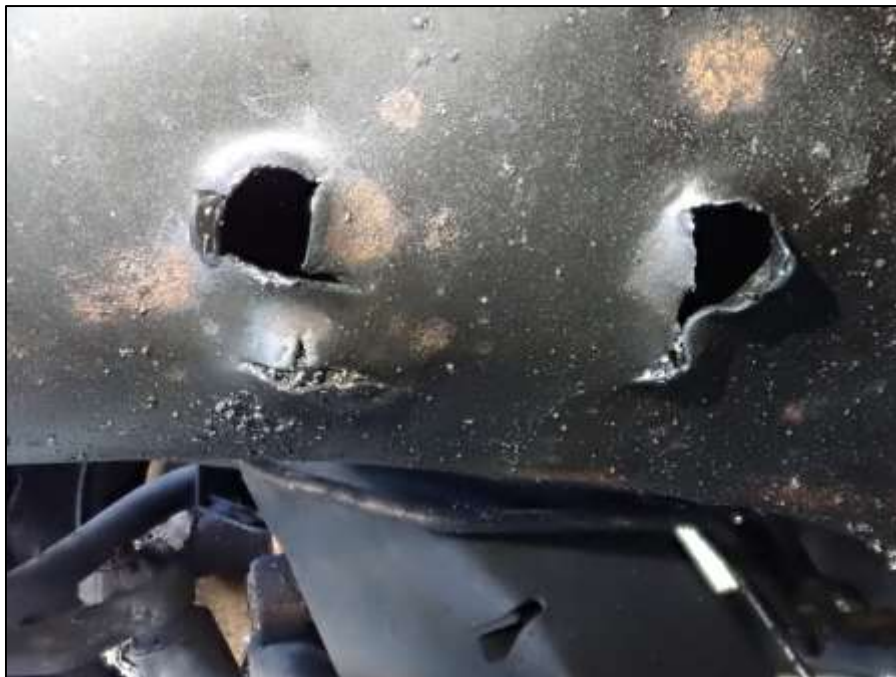
Photograph 17

Holes in the oil pan directly under cylinder #1.

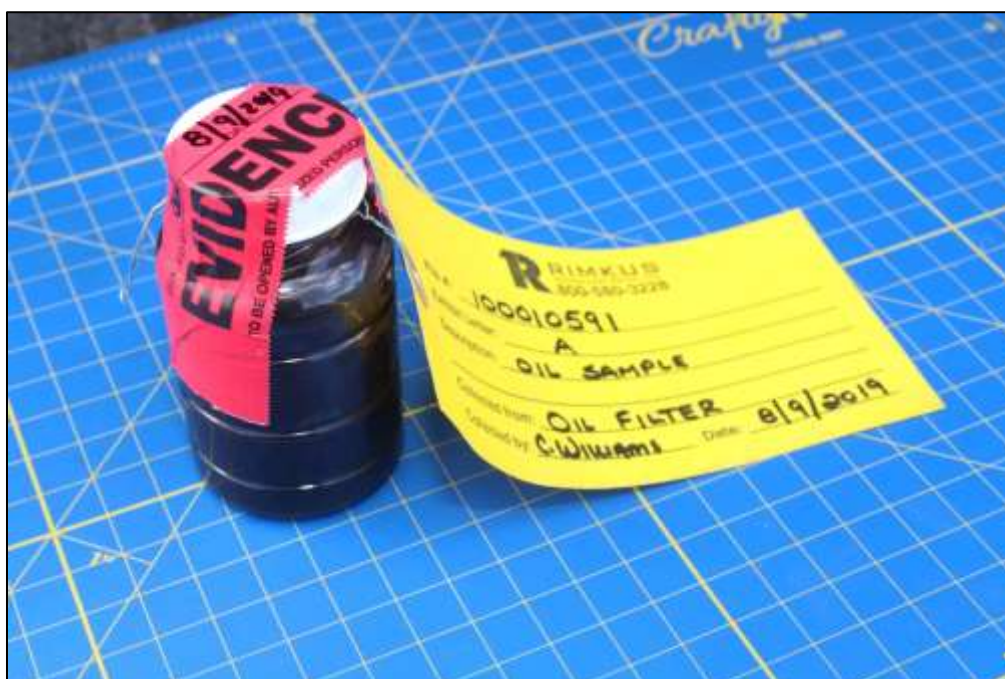
Photograph 18

Oil sample collected from the oil filter for lab analysis.

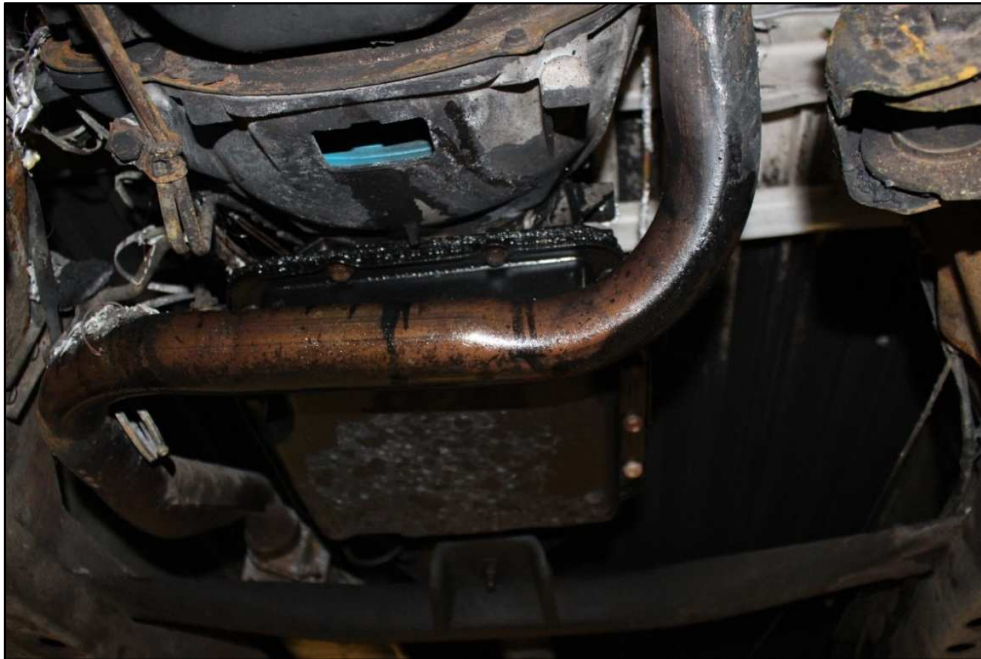
Photograph 5

View of the forward portion of transmission (note leaking fluid).

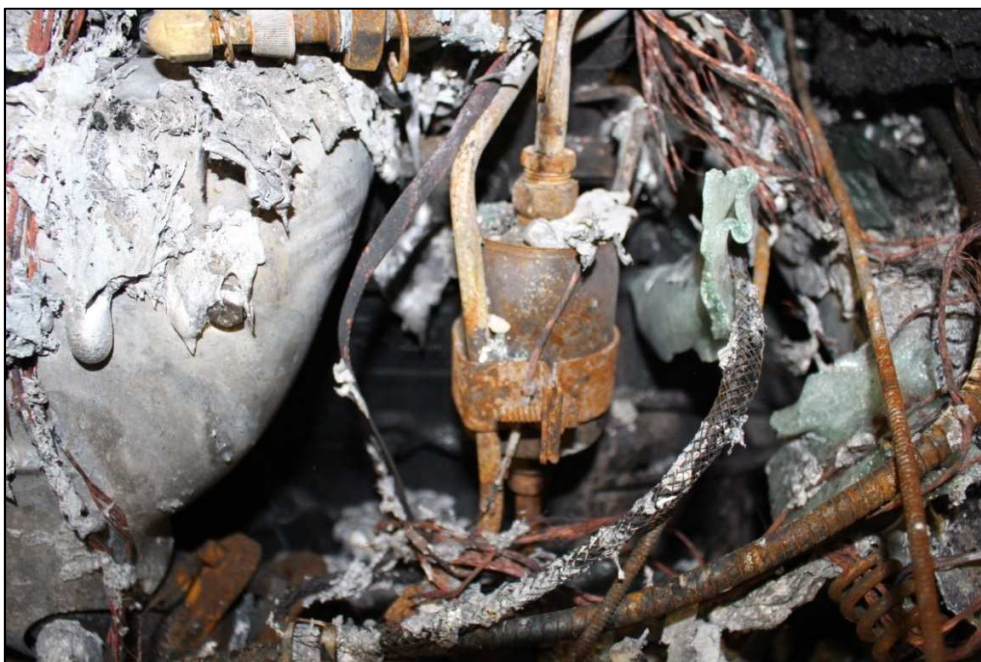
Photograph 8

View of the fuel filter.

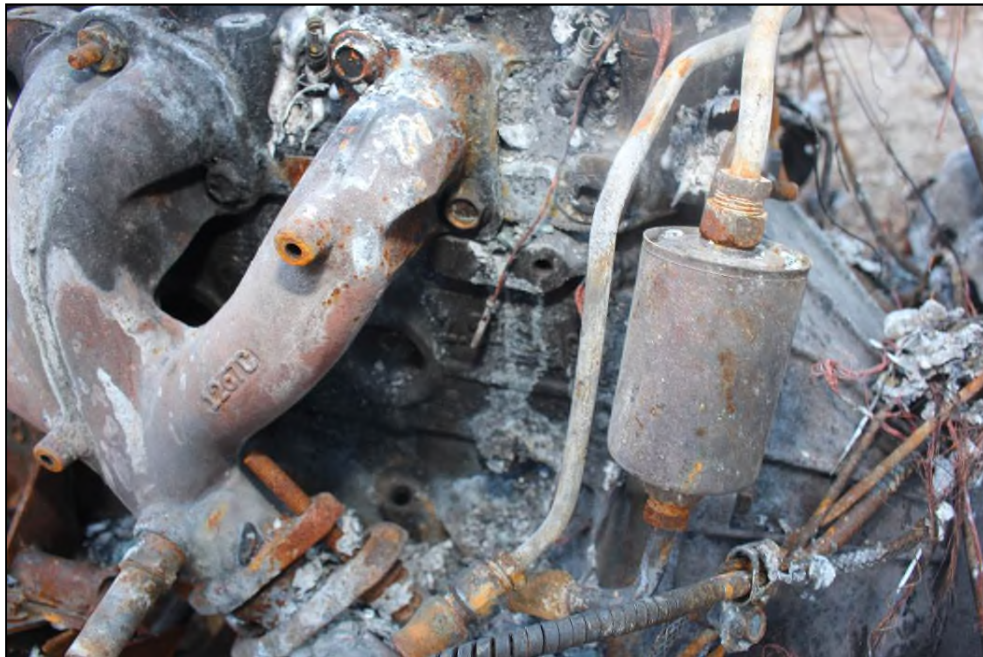
Photograph 4

View of the fuel filter and fuel lines adjacent to the exhaust manifold.

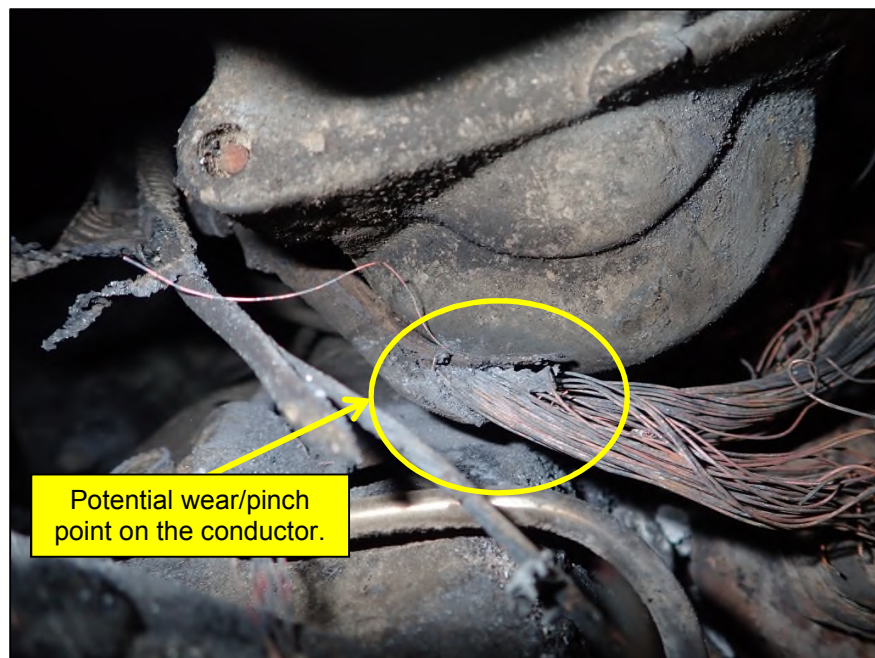
Photograph 12

Positive conductor from the battery to the starter on the burned vehicle.

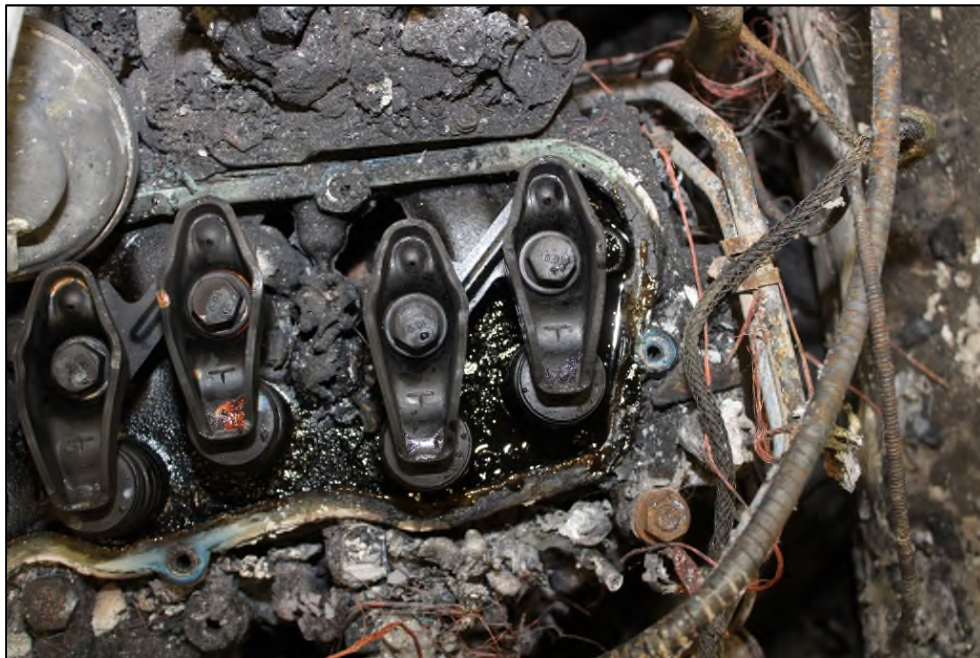
Photograph 16

Close-up of the valve cover gasket at the area of the oil leak.

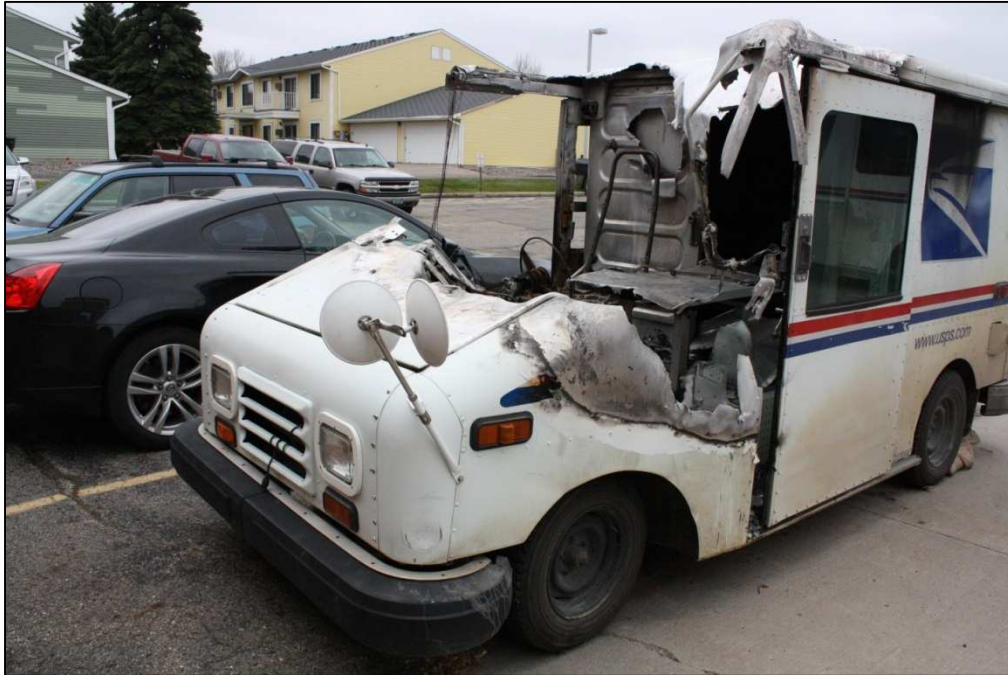
The exterior examination of the vehicle revealed heat and fire damage to the operator's compartment of the LLV.

Photograph 1
Exterior of LLV.

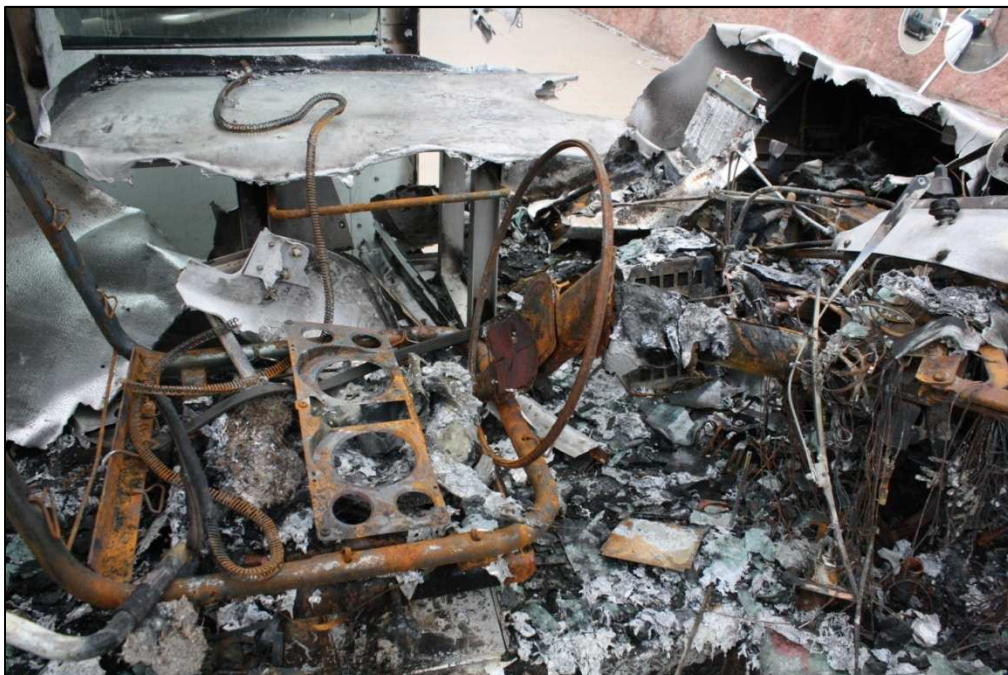
The interior examination of the vehicle, including the operator's and cargo compartments was conducted working from the areas of least fire damage to the area of greatest fire damage. Our interior examination revealed extensive fire and heat damage to the operator's compartment at the center of the dash area of the LLV.

Photograph 2
LLV operator's compartment.

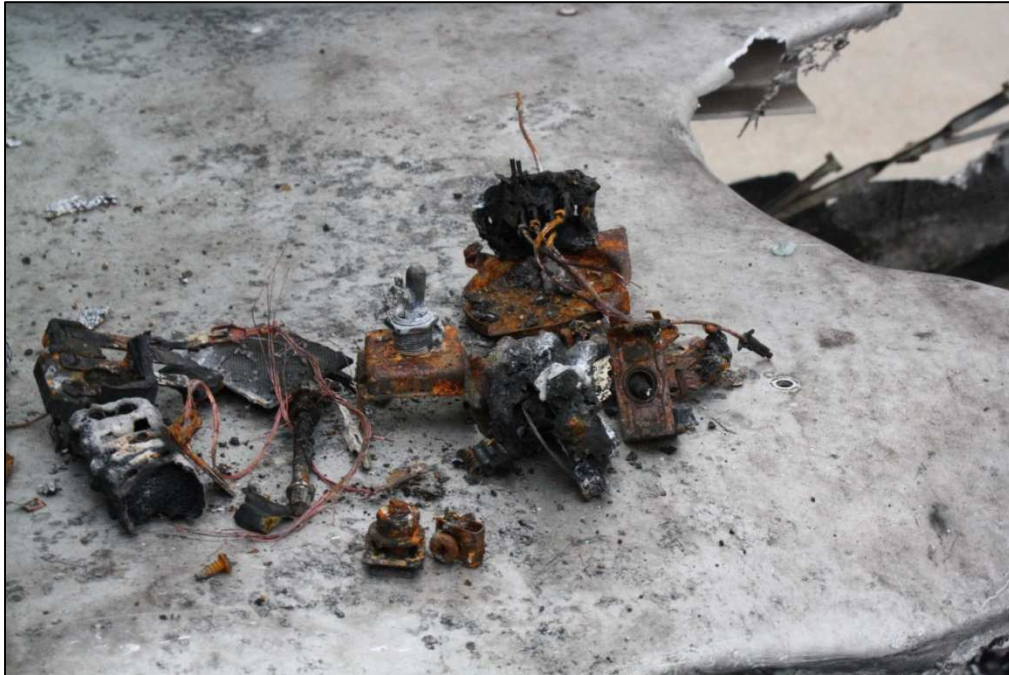
Photograph 3

All evidence/artifacts were transferred to Jack R. Kennedy III, in our Charlotte, North Carolina office, for secured storage. Collected evidence was examined and documented in the lab. The evidence inspection confirmed the failure of the headlamp switch in the area of fire origin.

Debris of switches and gauges collected from the operator's floor area.

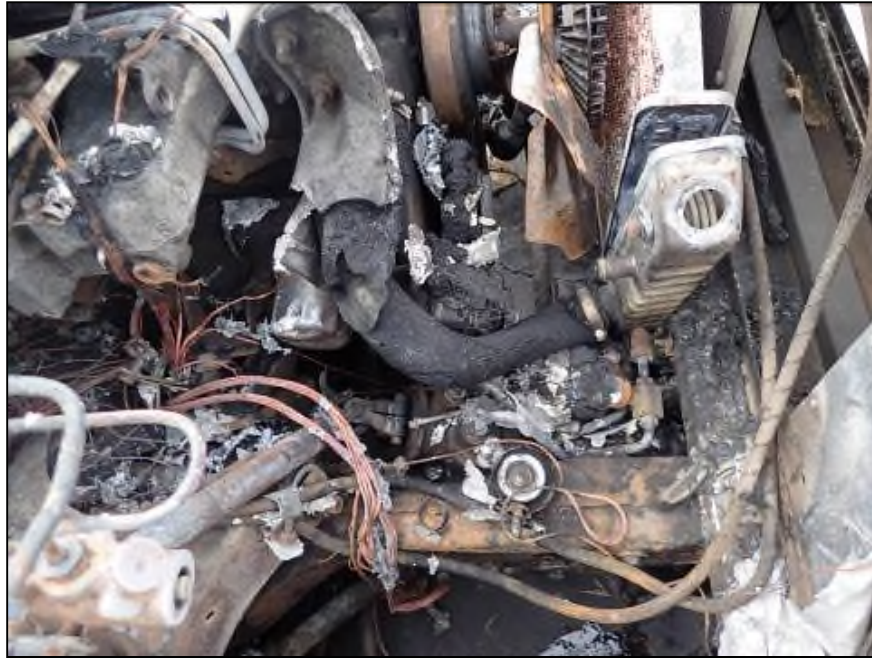
Photograph 5

View of the lower and upper radiator hoses on the driver side of the engine.

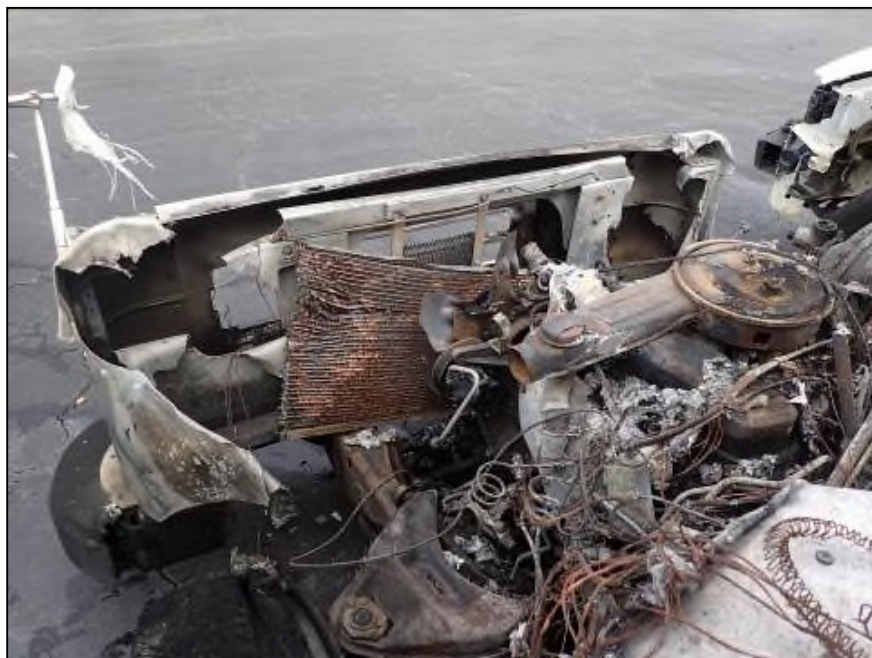
Photograph 6

View of the radiator.

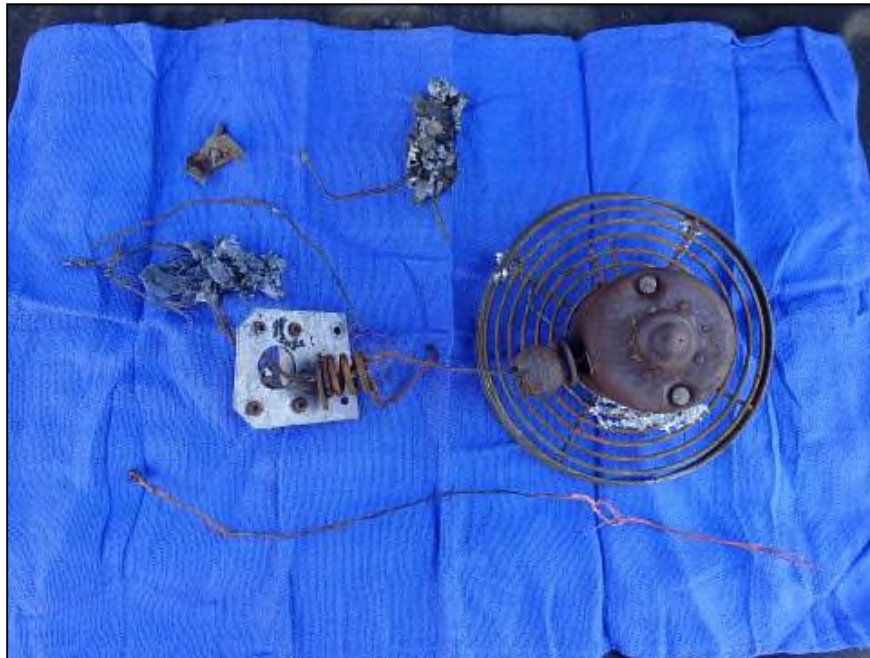
Photograph 9

View of the collected artifacts from the vehicle.

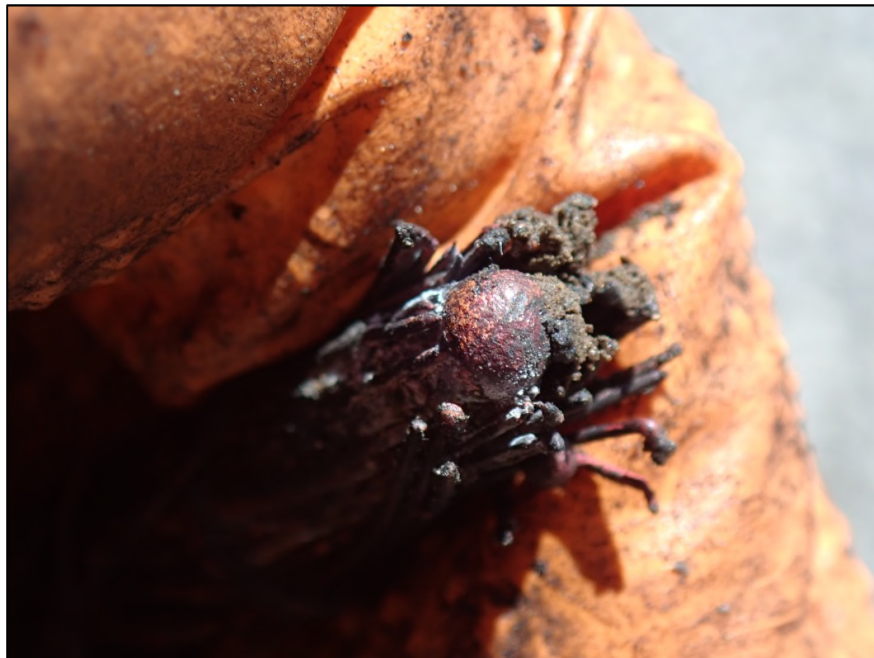
Photograph 10

Close up view of electrical activity at the battery cable to the engine starter.

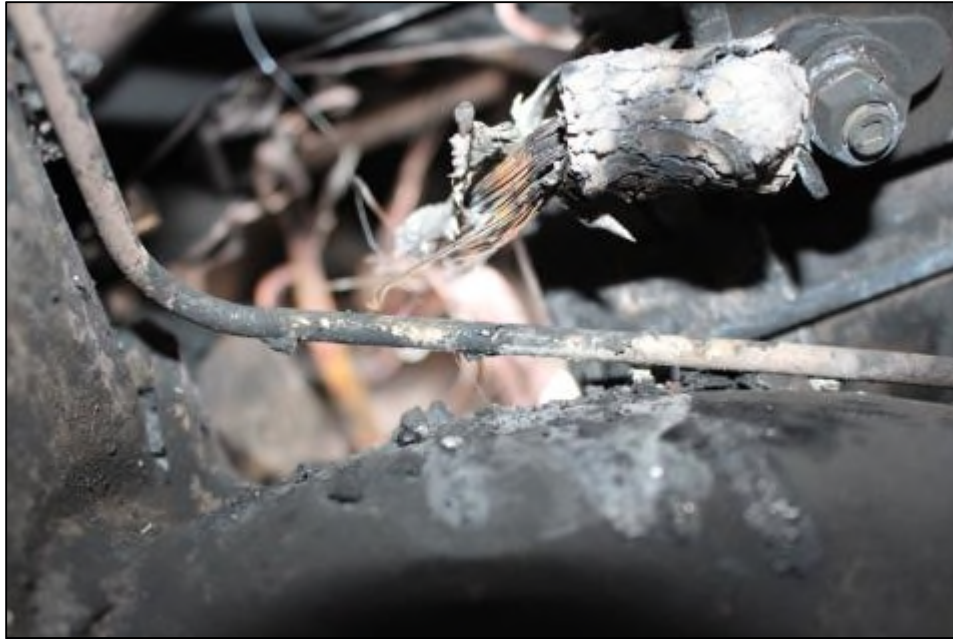
Photograph 7

Conductor for starter on the underside of vehicle.

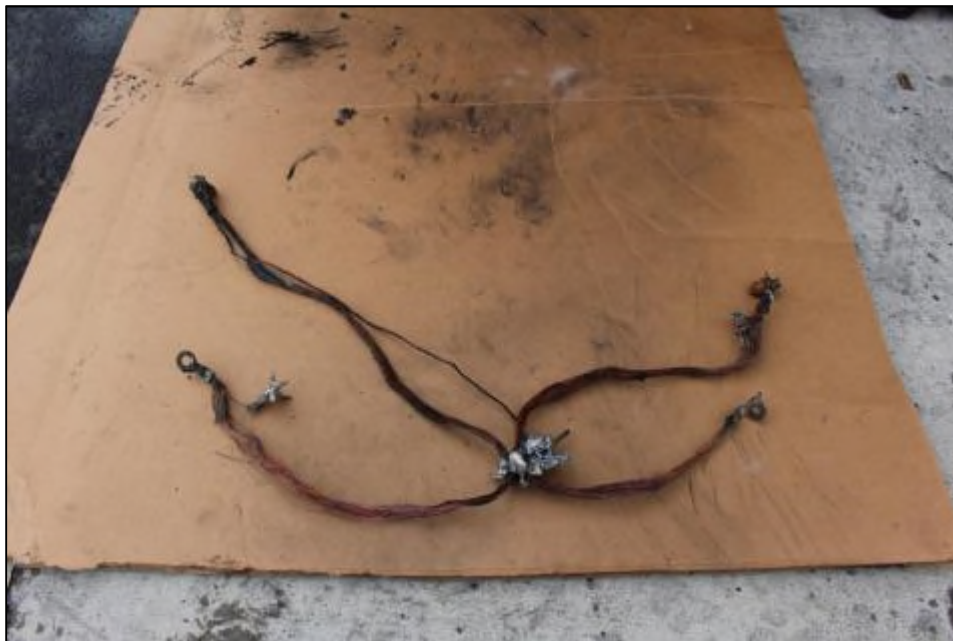
Photograph 8

Conductor for starter removed.

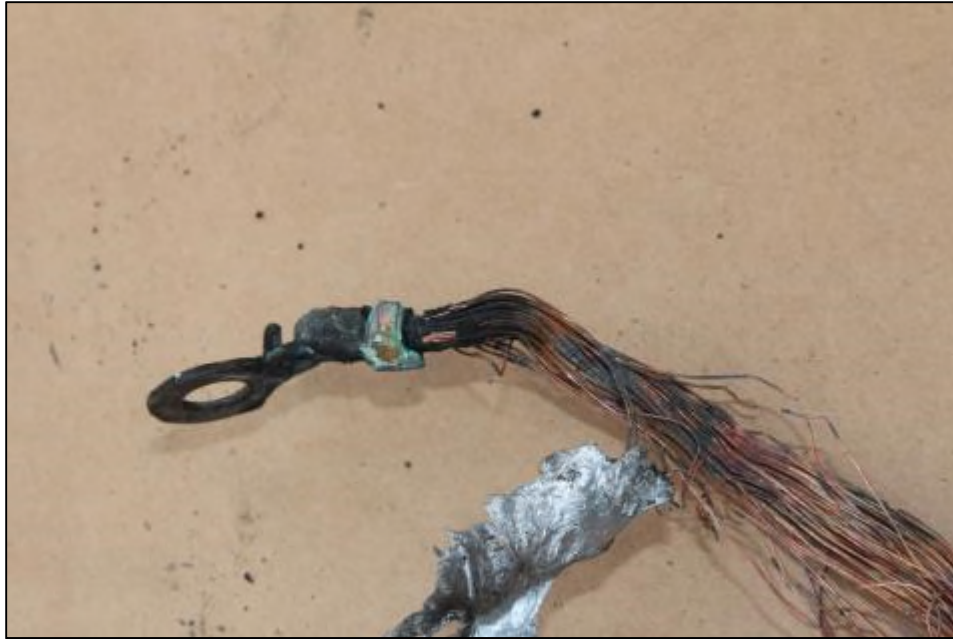
Photograph 9

Conductor for starter.

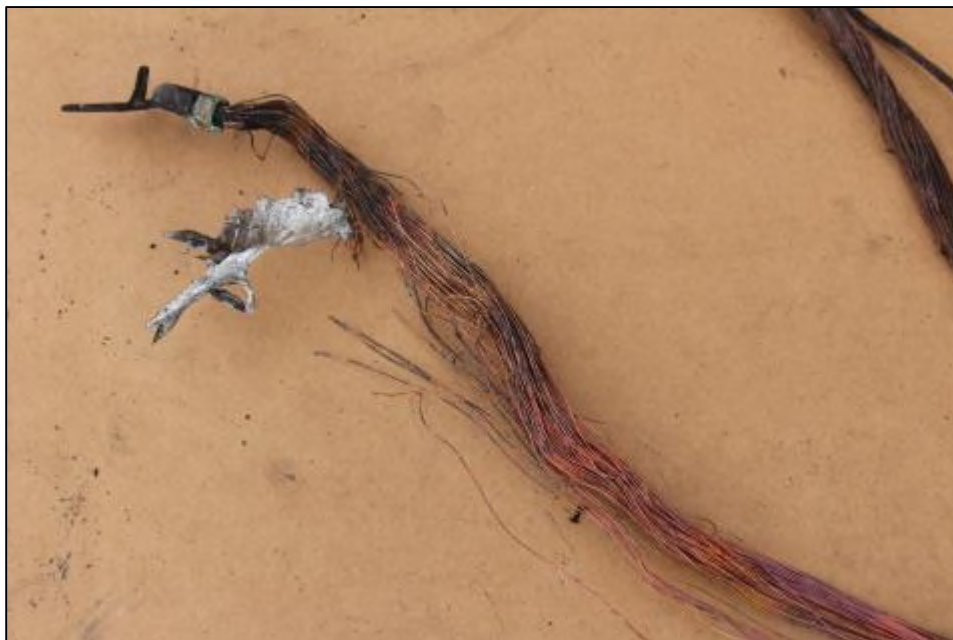
Photograph 10

Conductor for starter.

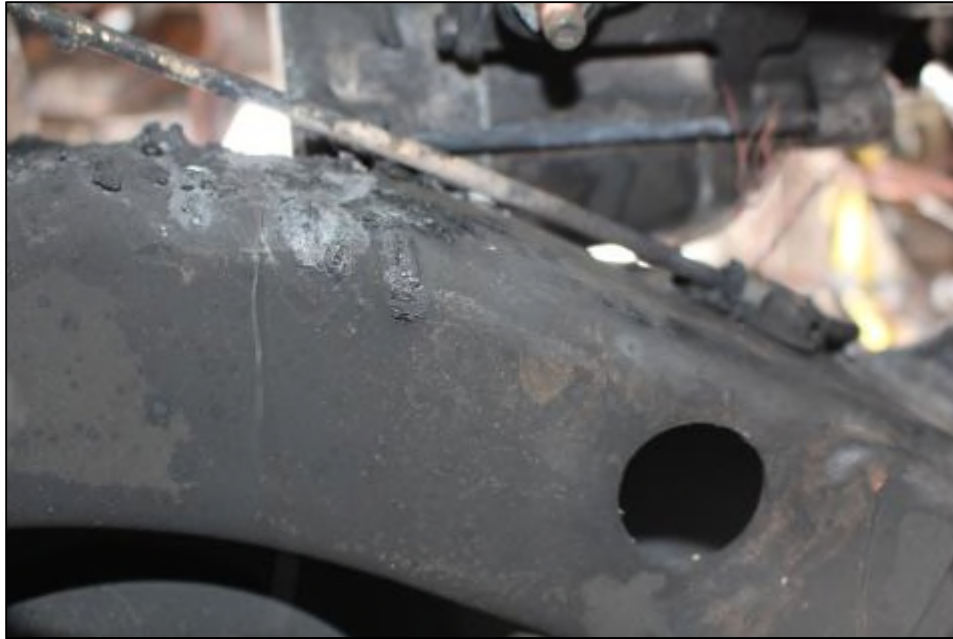
Photograph 11

Area of frame where starter conductor was routed.

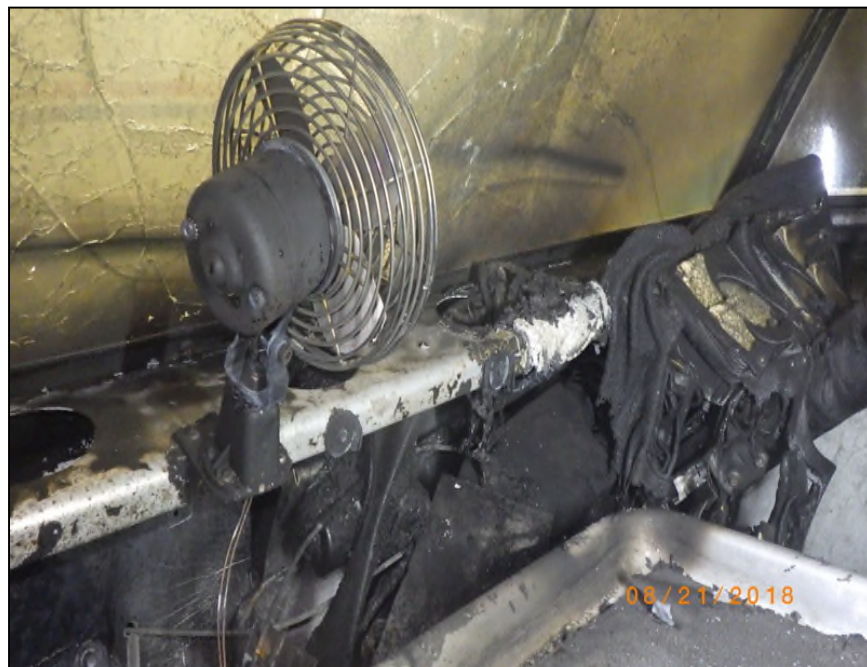
Photograph 6

A view of the interior driver compartment left side.

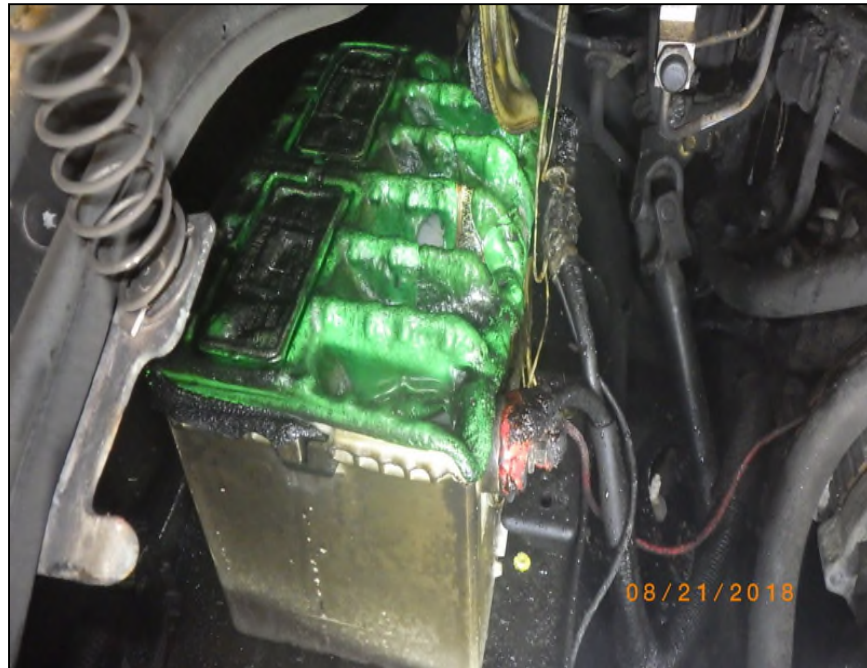
Photograph 7

A view of the battery on the right side of the engine compartment.
